# HL3.1: Microstructure analysis (before and) after permeation experiments: Zuidwending cavern field

*Version 240409*

**MaP Microstructures and Pores GmbH**

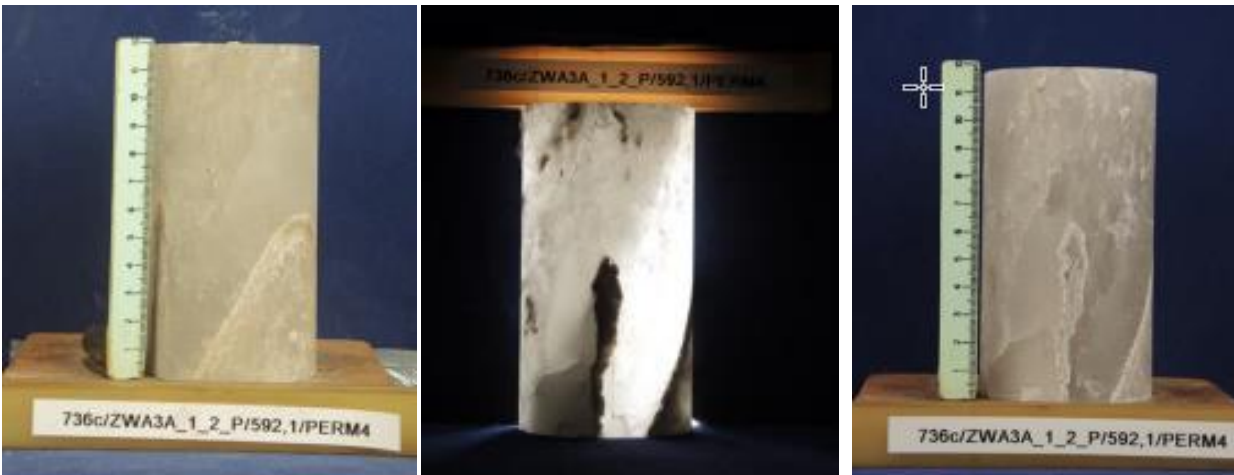
Figure 19: Photos of ZW\_Perm4 showing the selected core piece before the experiment at ambient light (left), with transmitted light (middle) and after the experiment at ambient light conditions (right) (pictures from IfG).

This sample was selected from a depth of 592.1 m from well ZW-A3A core number 1 and box number 2. In the selected core piece, the anhydrite is primarily concentrated in nodules, with only minimal anhydrite dust visible. The core piece exhibits a mylonitic fabric and is predominantly composed of a fine- to coarse-grained matrix halite (Figure 19). Furthermore, an a few mm thick anhydrite band is located at the other edge of the test cylinder. The tubing and mini cavern were placed into matrix halite in a location with accumulated anhydrite nodules.

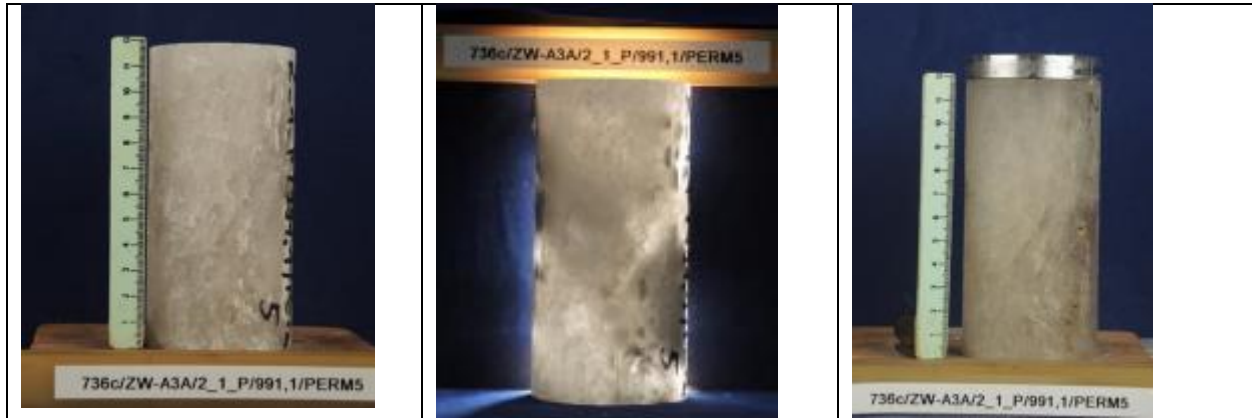
Figure 26: Photos of ZW\_Perm5 showing the selected core piece before the experiment at ambient light (left), with transmitted light (middle) and after the experiment at ambient light conditions (right) (pictures from IfG).

ZW-Perm5 was chosen from a depth of 991.1 m in well ZW-A3A core number 2 and box slab number 1. It comprises a predominantly coarse-grained matrix halite with scattered layers of anhydrite dust or small nodules. Exhibiting a mylonitic fabric, the selected core piece reveals minor halite mega-grains (Figure 26). The tubing was positioned between matrix halite and anhydrite dust.

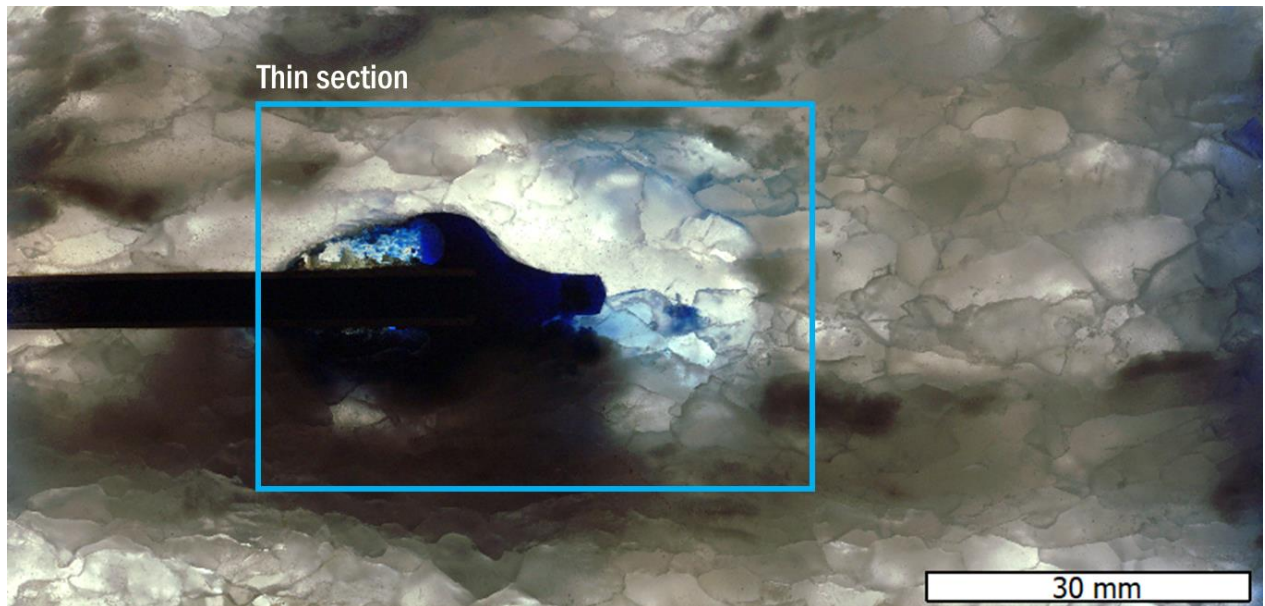
Figure 28: Transmitted light image of the ZW\_Perm5 slab indicating the position of the thin section.
